Manhole Inspection Summary

Manhole # S35MM1016MH

Insp Date: **10/20/08 11:20 AM**

Location Address: **309 OLD COLDSRING LN**

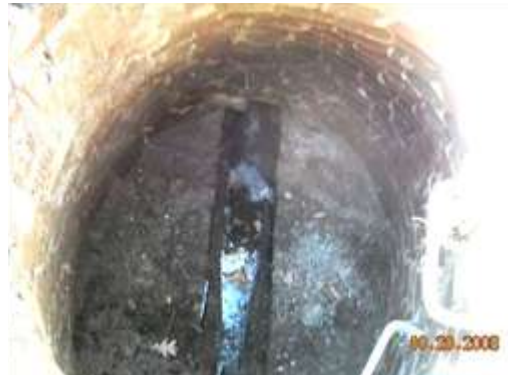
Top View

Infiltration: ☐ None ☐ Joint ☐ Cracks ☒ **Mortar** ☐ Roots ☒ **Wall**

Bench ☒ Exists Material: **Brick** ☐ Parged ☒ **Debris** (not Condition related)

Surcharge ☒ **Evidence Of Surcharge** Depth: **1** (ft.) ☐ Active Surcharge Present

Corbel infiltration. Evidence of surcharge - Bench debris.

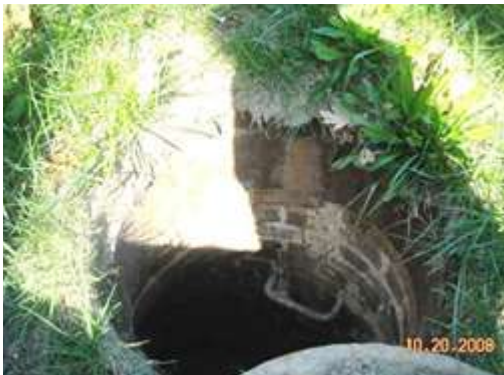
Defect

Infiltration: ☐ None ☒ **Joint** ☐ Cracks ☐ Mortar ☐ Roots ☐ Wall

Adjustment infiltration.

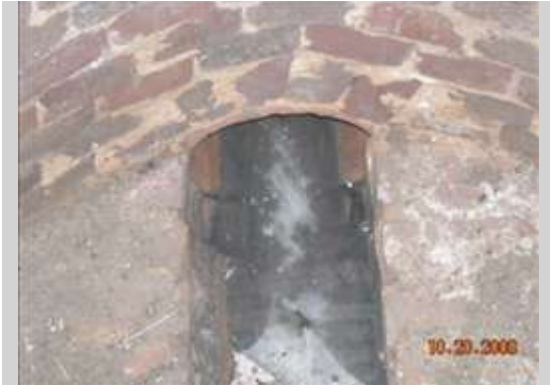
8 in. Circular Gravity Sewer Pipe Out @ 12 O'Clock

Invert Depth: **5.84** (ft.) Flow Characteristics: **Slow**

Deposits: ☐ None ☒ **Mud** ☐ Sludge ☒ **Debris** ☐ Grease

Silt Depth: **0.5** (in.) Deposits Extent: **Light**

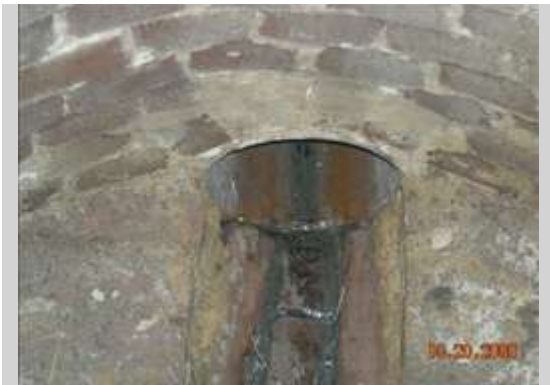
8 in. Circular Gravity Sewer Pipe In @ 6 O'Clock

Invert Depth: **5.53** (ft.) Flow Characteristics: **Slow**

Deposits: ☒ **None** ☐ Mud ☐ Sludge ☐ Debris ☐ Grease
